**SUB:- STUDY REPORT ON HIGH SHAFT VIBRATION PROBLEM OF  
TURBINE GENERATOR OF RIHAND UNIT#4 (500 MW)**

**STUDY REPORT ON HIGH SHAFT VIBRATION PROBLEM  
OF TG#4 (500 MW)  
AT  
RIHAND STPS [6x500 MW]**

**RIHAND SUPER THERMAL POWER STATION  
NTPC LIMITED, RIHAND, (UP)**

# SUB: STUDY REPORT ON HIGH SHAFT VIBRATION PROBLEM OF TURBINE GENERATOR UNIT#4 (500 MW)

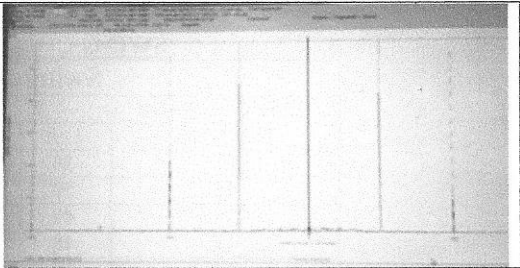
Figure No 2 (b)

vii) A bearing preload due to cocked assembly can also cause orbit to have lower amplitude in one axis that makes the ellipse look thinner as shown in Figure 2(a). But heavy preloading due to misalignment can cause the shaft to go into sometime reverse precession; can be seen in Figure No 2(b). The forward precession is normal; reverse is not can be seen in full spectrum taken during load on 15<sup>th</sup> August 2019.

Reverse Precession

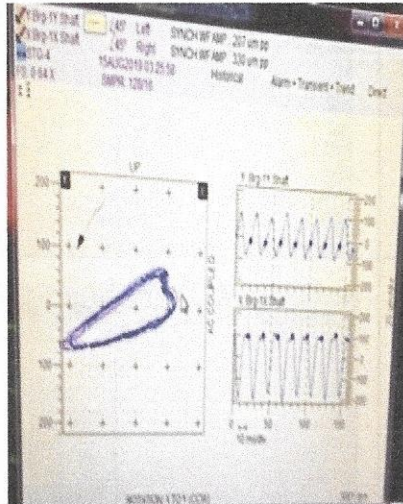
Overall vibration orbit

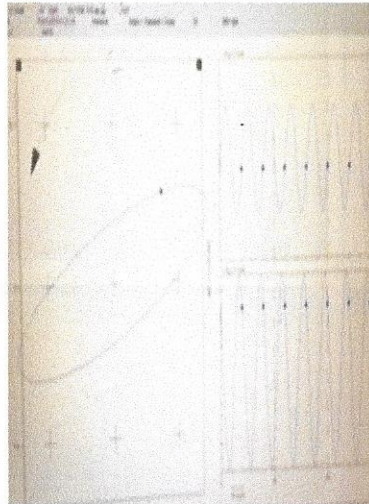
Filtered orbit

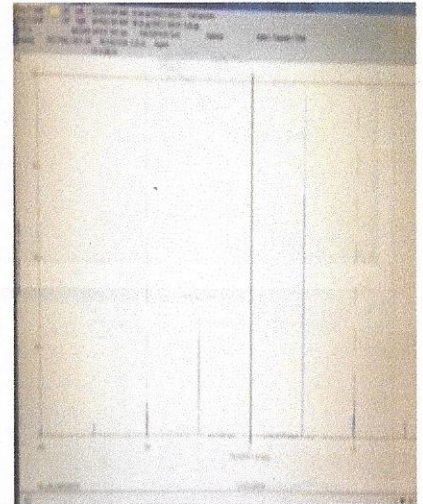
Full Spectrum
